# **Report on Energy Audit and MEP Audit for VES Institute of Management Studies & Research, Chembur**

**Energetic Consulting Pvt. Ltd.,  
228, Jai Commercial Complex,  
Cadbury Junction, Khopat Road,  
Thane (West) – 400 601**

June 2022

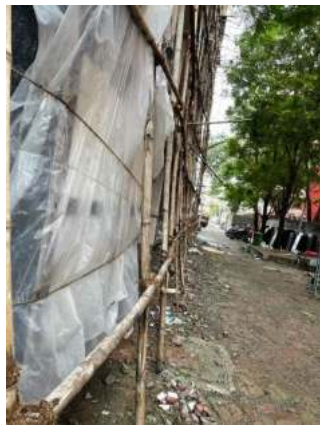
| Sr. No. | Observations | Remarks | Photo | Remarks |
|---|---|---|---|---|
| 1.1 | B Wing distribution panel situated outside of meter room | B Wing meter panel are situated outside of meter room, due to monsoon season panel is covered with polythene. | | Dust and dirt proof along with water splash proof panel (IP 65) should be provided for switchgear protection |

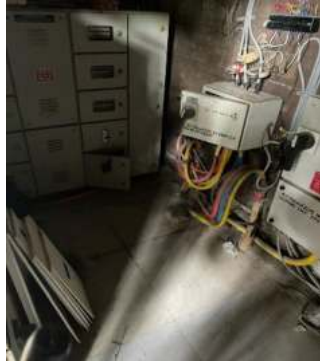
| Sr. No. | Observations | Remarks | Photo | Remarks |
|---|---|---|---|---|
| 1.2 | Missing provision of Earth mat in meter room | Safety earth mat was not provided for meter room | | Earth mat of 1.1kV 2 mm thickness should be provided for meter room |

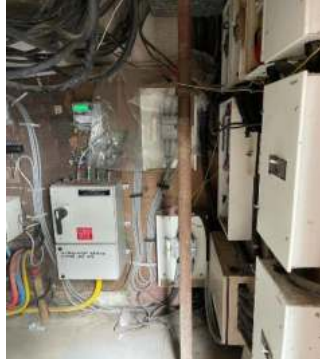
| Sr. No. | Observations | Remarks | Photo | Remarks |
|---|---|---|---|---|
| 1.3 | Missing provision of Earth mat in meter room | Safety earth mat was not provided for meter room | | Earth mat of 1.1kV 2 mm thickness should be provided for meter room |

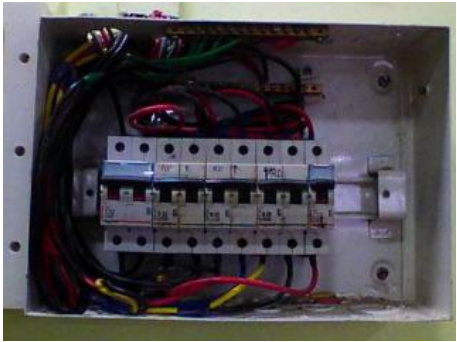
| Sr. No. | Thermal Image | Visual Image | Remarks |
|---|---|---|---|
| 1 | | | <b>Location:</b> Fourth Floor, B404 - Classroom, Main Incomer<br><b>Code:</b> 5<br><b>Remarks:</b> Normal<br>No action |

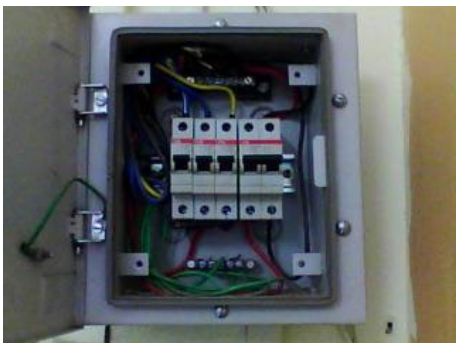
| Sr. No. | Thermal Image | Visual Image | Remarks |
|---|---|---|---|
| 2 | | | <b>Location:</b> Fourth Floor, B401 - Staffroom, Main Incomer<br><b>Code:</b> 2<br><b>Remarks:</b> Critical.<br>Immediate rectification is recommended at the earliest |

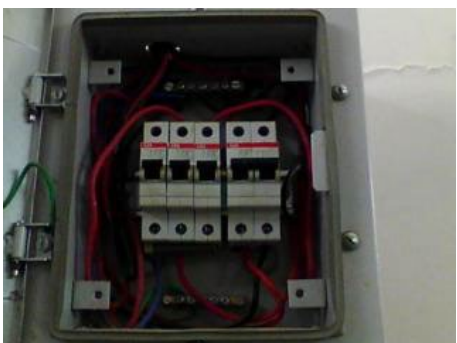
| Sr. No. | Thermal Image | Visual Image | Remarks |
|---|---|---|---|
| 3 | | | <b>Location:</b> Fourth Floor, B405, Main Incomer<br><b>Code:</b> 5<br><b>Remarks:</b> Normal<br>No action |

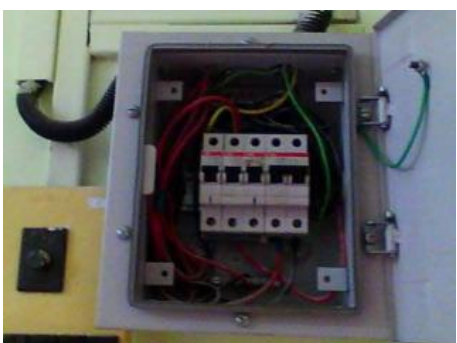
| Sr. No. | Thermal Image | Visual Image | Remarks |
|---|---|---|---|
| 4 | | | <b>Location:</b> Third Floor, A-301, Main Incomer<br><b>Code:</b> 5<br><b>Remarks:</b> Normal<br>No action |

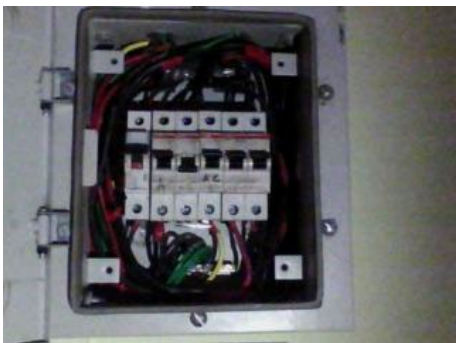
| Sr. No. | Thermal Image | Visual Image | Remarks |
|---|---|---|---|
| 6 | | | <b>Location:</b> Third Floor, A-302, Main Incomer<br><b>Code:</b> 4<br><b>Remarks:</b> Alert<br>Monitoring recommended |

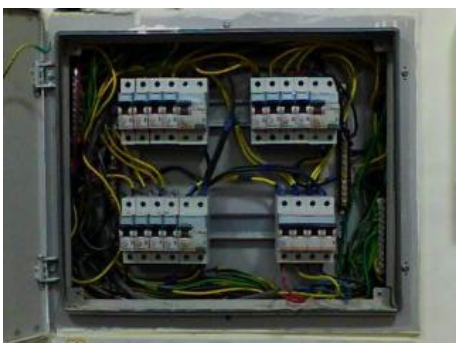
| Sr. No. | Thermal Image | Visual Image | Remarks |
|---|---|---|---|
| 7 | | | <b>Location:</b> Third Floor, A-304 Lab-II SAS Lab, Main Incomer<br><b>Code:</b> 5<br><b>Remarks:</b> Normal<br>No action |

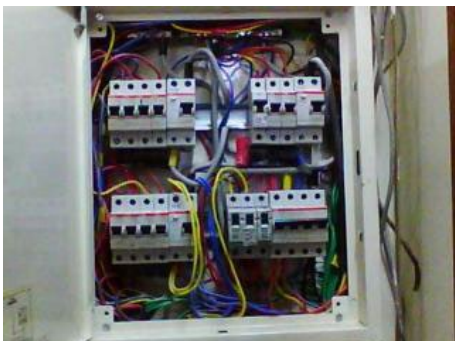
| Sr. No. | Thermal Image | Visual Image | Remarks |
|---|---|---|---|
| 10 | | | <b>Location:</b> Third Floor, A-303 Computer Lab, Main Incomer<br><b>Code:</b> 5<br><b>Remarks:</b> Normal<br>No action |

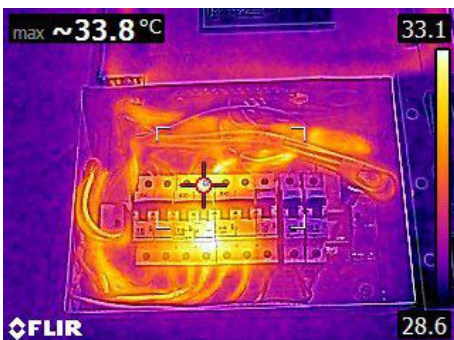
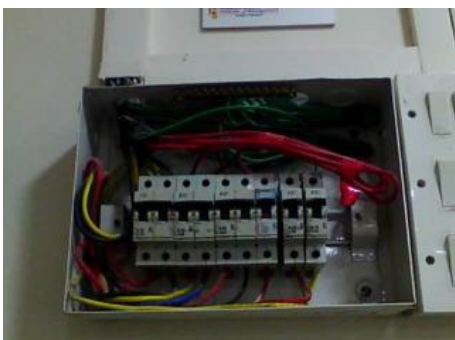
| Sr. No. | Thermal Image | Visual Image | Remarks |
|---|---|---|---|
| 11 | | | <b>Location:</b> Third Floor, B-303 Classroom-4, Main Incomer<br><b>Code:</b> 5<br><b>Remarks:</b> Normal<br>No action |

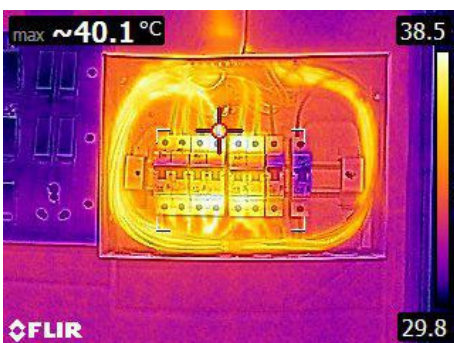
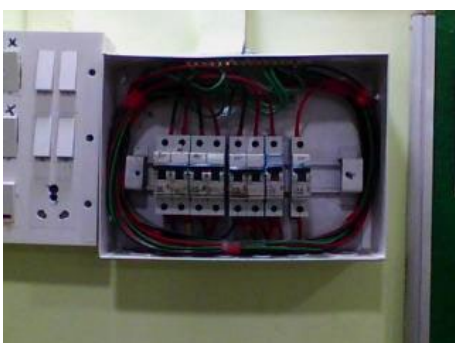
| Sr. No. | Thermal Image | Visual Image | Remarks |
|---|---|---|---|
| 12 | | | <b>Location:</b> Third Floor, B-304 Classroom-4, Main Incomer<br><b>Code:</b> 5<br><b>Remarks:</b> Normal<br>No action |

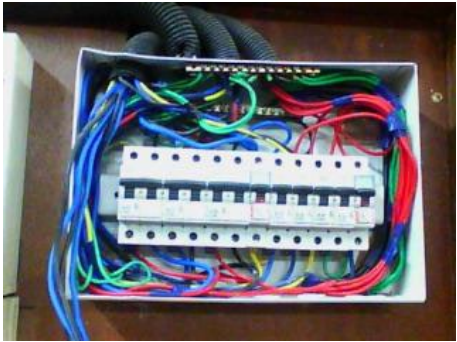
| Sr. No. | Thermal Image | Visual Image | Remarks |
|---|---|---|---|
| 13 | | | <b>Location:</b> Third Floor, B-302 Coordination and Exam Department, Main Incomer<br><b>Code:</b> 5<br><b>Remarks:</b> Normal<br>No action |

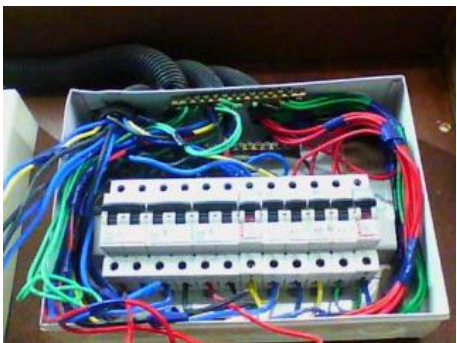
| Sr. No. | Thermal Image | Visual Image | Remarks |
|---|---|---|---|
| 14 | | | <b>Location:</b> Third Floor, B-302 Coordination and Exam Department, Main Incomer<br><b>Code:</b> 5<br><b>Remarks:</b> Normal<br>No action |

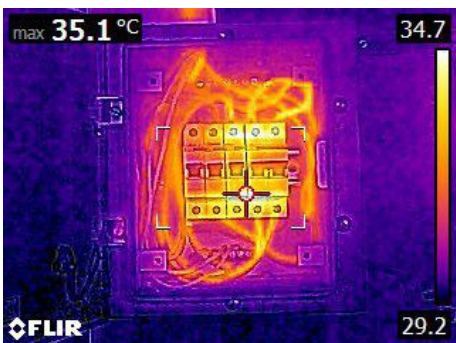
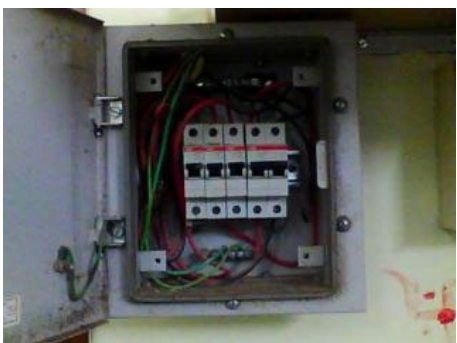
| Sr. No. | Thermal Image | Visual Image | Remarks |
|---|---|---|---|
| 15 | | | <b>Location:</b> Third Floor, B-301, Main Incomer<br><b>Code:</b> 5<br><b>Remarks:</b> Normal<br>No action |

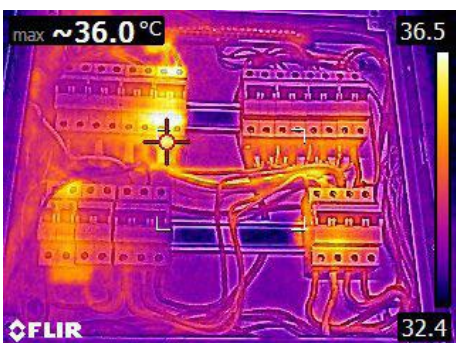
| Sr. No. | Thermal Image | Visual Image | Remarks |
|---|---|---|---|
| 16 | | | <b>Location:</b> Third Floor, B-Wing, Main DB.<br><b>Code:</b> 5<br><b>Remarks:</b> Normal<br>No action |

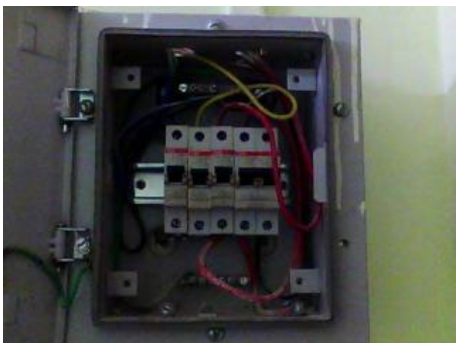
| Sr. No. | Thermal Image | Visual Image | Remarks |
|---|---|---|---|
| 18 | | | <b>Location:</b> Second Floor, 201-Faculty room<br><b>Code:</b> 5<br><b>Remarks:</b> Normal<br>No action |

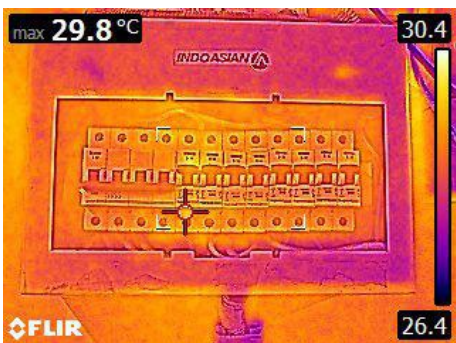
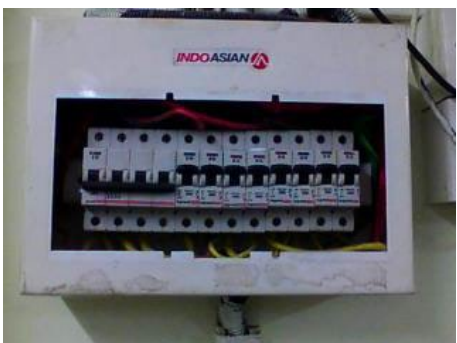
| Sr. No. | Thermal Image | Visual Image | Remarks |
|---|---|---|---|
| 19 | | | <b>Location:</b> Second Floor, 205-Faculty room<br><b>Code:</b> 5<br><b>Remarks:</b> Normal<br>No action |

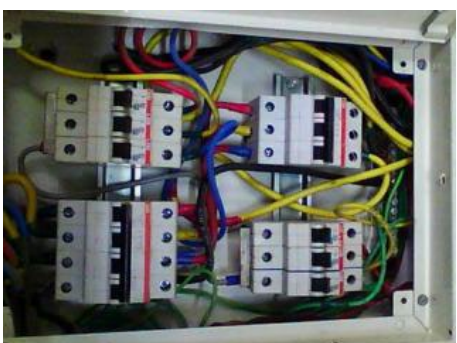
| Sr. No. | Thermal Image | Visual Image | Remarks |
|---|---|---|---|
| 20 | | | <b>Location:</b> Second Floor, A-Wing near Lift<br><b>Code:</b> 5<br><b>Remarks:</b> Normal<br>No action |

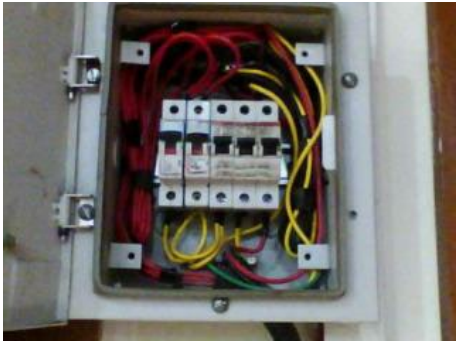
| Sr. No. | Thermal Image | Visual Image | Remarks |
|---|---|---|---|
| 21 | | | <b>Location:</b> Second Floor, A-202 Girls' Lounge<br><b>Code:</b> 4<br><b>Remarks:</b> Alert<br>Monitoring recommended |

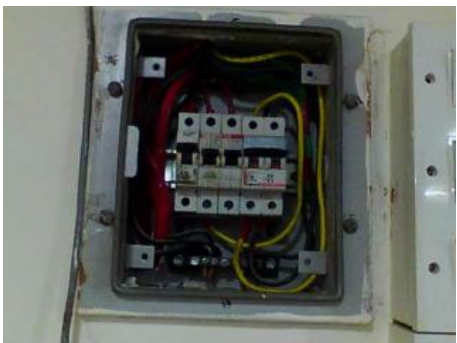
| Sr. No. | Thermal Image | Visual Image | Remarks |
|---|---|---|---|
| 22 | | | <b>Location:</b> Second Floor, A-203 Boys' Lounge<br><b>Code:</b> 5<br><b>Remarks:</b> Normal<br>No action |

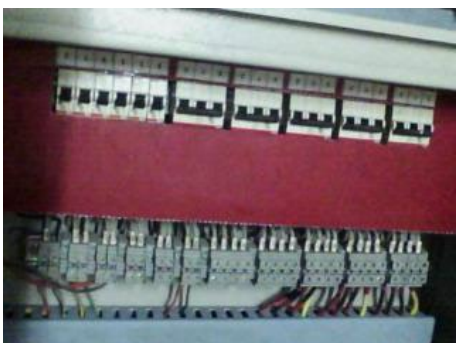
| Sr. No. | Thermal Image | Visual Image | Remarks |
|---|---|---|---|
| 23 | | | <b>Location:</b> Second Floor, B-Wing, Main DB<br><b>Code:</b> 5<br><b>Remarks:</b> Normal<br>No action |

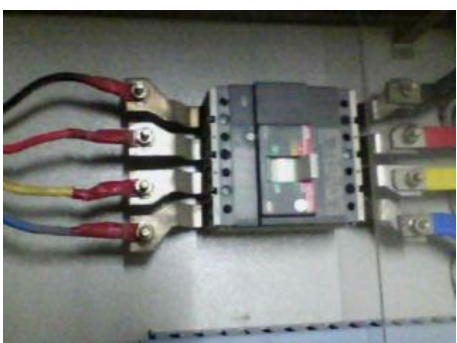
| Sr. No. | Thermal Image | Visual Image | Remarks |
|---|---|---|---|
| 24 | | | <b>Location:</b> Second Floor, B-Wing, Main DB<br><b>Code:</b> 5<br><b>Remarks:</b> Normal<br>No action |

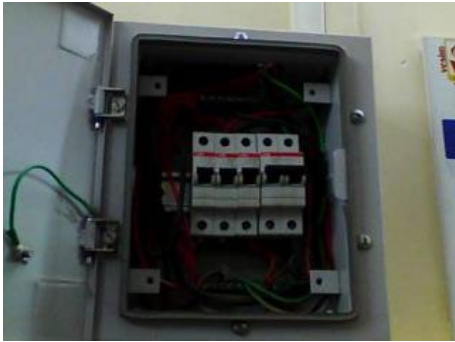
| Sr. No. | Thermal Image | Visual Image | Remarks |
|---|---|---|---|
| 25 | | | <b>Location:</b> Second Floor, B-205 Faculty room.<br><b>Code:</b> 5<br><b>Remarks:</b> Normal<br>No action |

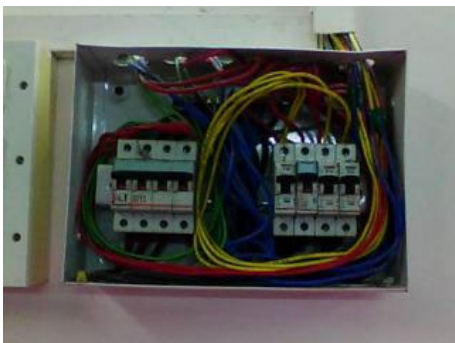
| Sr. No. | Thermal Image | Visual Image | Remarks |
|---|---|---|---|
| 26 | | | <b>Location:</b> Second Floor, B-202<br><b>Code:</b> 5<br><b>Remarks:</b> Normal<br>No action |

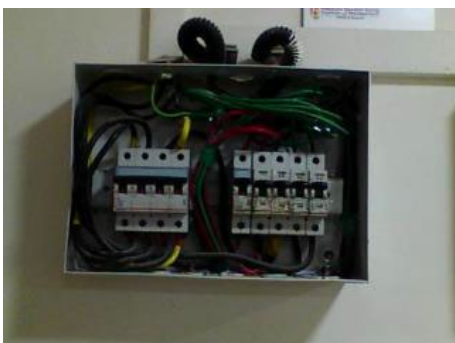
| Sr. No. | Thermal Image | Visual Image | Remarks |
|---|---|---|---|
| 27 | | | <b>Location:</b> Second Floor, B-203<br><b>Code:</b> 5<br><b>Remarks:</b> Normal<br>No action |

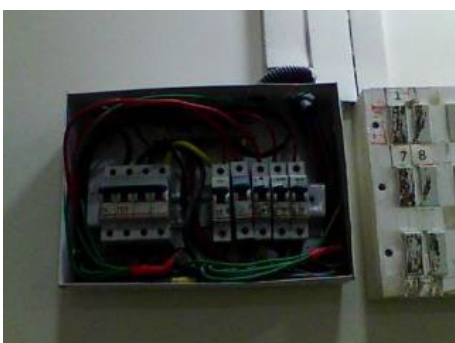
| Sr. No. | Thermal Image | Visual Image | Remarks |
|---|---|---|---|
| 28 | | | <b>Location:</b> Second Floor, B-204 Classroom<br><b>Code:</b> 4<br><b>Remarks:</b> Alert<br>Monitoring recommended |

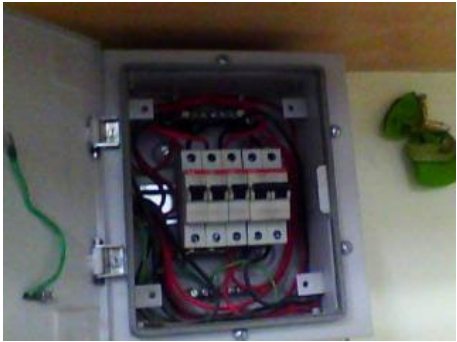
| Sr. No. | Thermal Image | Visual Image | Remarks |
|---|---|---|---|
| 29 | | | <b>Location:</b> Second Floor, B-201 Faculty room (HOD room).<br><b>Code:</b> 5<br><b>Remarks:</b> Normal<br>No action |

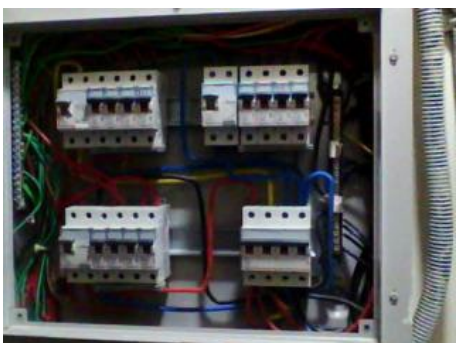
| Sr. No. | Thermal Image | Visual Image | Remarks |
|---|---|---|---|
| 31 | | | <b>Location:</b> First Floor, A-Wing<br><b>Code:</b> 5<br><b>Remarks:</b> Normal<br>No action |

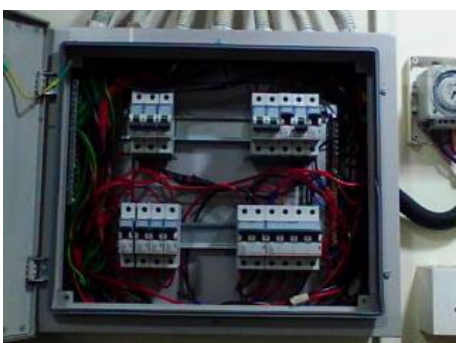
| Sr. No. | Thermal Image | Visual Image | Remarks |
|---|---|---|---|
| 32 | | | <b>Location:</b> First Floor, Server room, A 113<br><b>Code:</b> 5<br><b>Remarks:</b> Normal<br>No action |

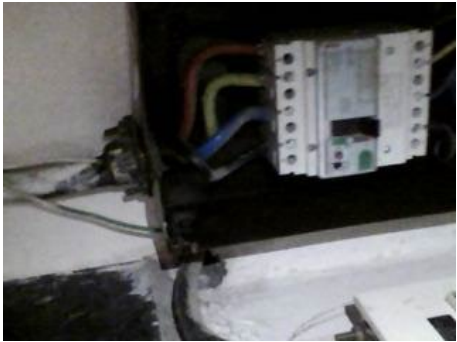
| Sr. No. | Thermal Image | Visual Image | Remarks |
|---|---|---|---|
| 33 | | | <b>Location:</b> First Floor, A-Wing<br><b>Main DB</b><br><b>Code: 5</b><br><b>Remarks: Normal</b><br>No action |

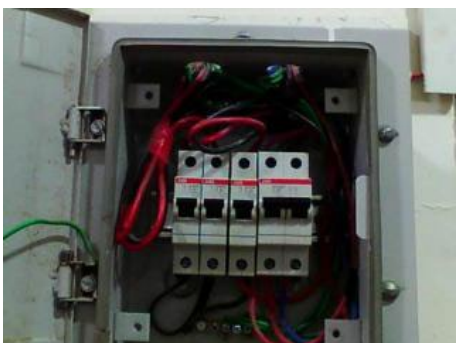
| Sr. No. | Thermal Image | Visual Image | Remarks |
|---|---|---|---|
| 35 | | | <b>Location:</b> First Floor, B-102, Dean Office<br><b>Code: 4</b><br><b>Remarks: Alert</b><br>Monitoring recommended |

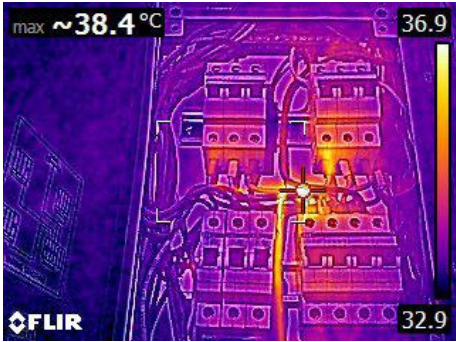
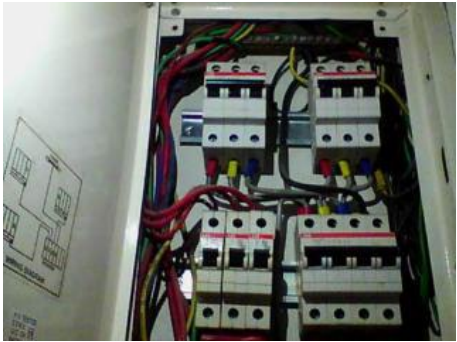
| Sr. No. | Thermal Image | Visual Image | Remarks |
|---|---|---|---|
| 37 | | | <b>Location:</b> First Floor, Main DB, Girls' Washroom.<br><b>Code:</b> 5<br><b>Remarks:</b> Normal<br>No action |

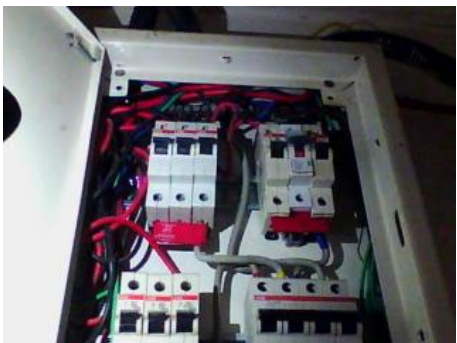
| Sr. No. | Thermal Image | Visual Image | Remarks |
|---|---|---|---|
| 38 | | | <b>Location:</b> First Floor, Main DB, Boys' Washroom.<br><b>Code:</b> 4<br><b>Remarks:</b> Alert<br>Monitoring recommended |

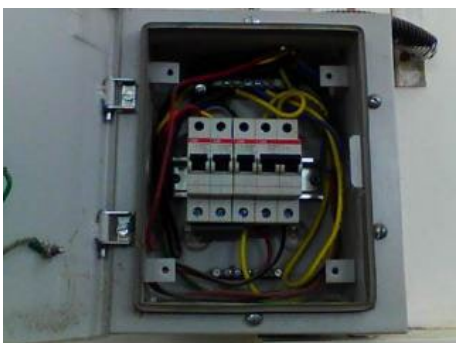
| Sr. No. | Thermal Image | Visual Image | Remarks |
|---|---|---|---|
| 39 | | | <b>Location:</b> First Floor, B-106<br><b>Code:</b> 5<br><b>Remarks:</b> Normal<br>No action |

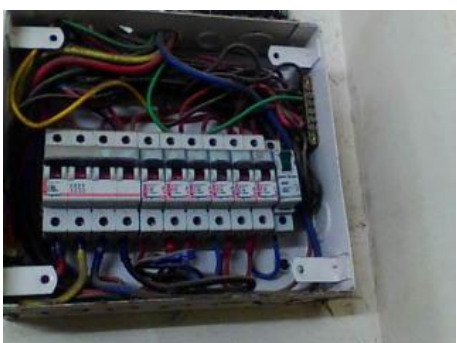
| Sr. No. | Thermal Image | Visual Image | Remarks |
|---|---|---|---|
| 40 | | | <b>Location:</b> First Floor, A-105 Admin Office (Reception).<br><b>Code:</b> 5<br><b>Remarks:</b> Normal<br>No action |

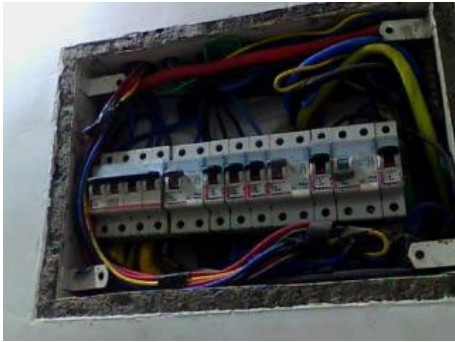
| Sr. No. | Thermal Image | Visual Image | Remarks |
|---|---|---|---|
| 41 | | | <b>Location:</b> First Floor, B-103 MBP<br><b>Code:</b> 5<br><b>Remarks:</b> Normal<br>No action |

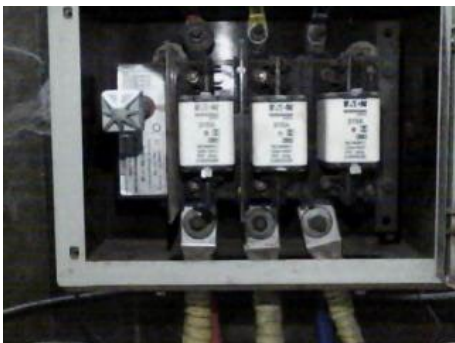
| Sr. No. | Thermal Image | Visual Image | Remarks |
|---|---|---|---|
| 42 | | | <b>Location:</b> Meter room, A-Wing<br><b>Main incomer</b><br><b>Code:</b> 4<br><b>Remarks:</b> Alert<br>Monitoring recommended |

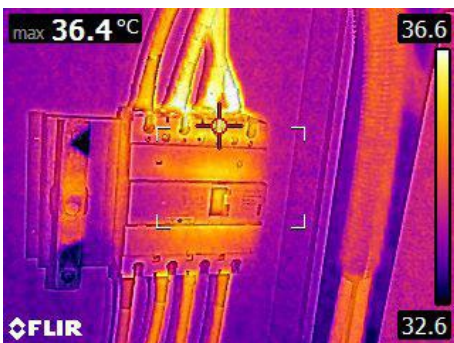
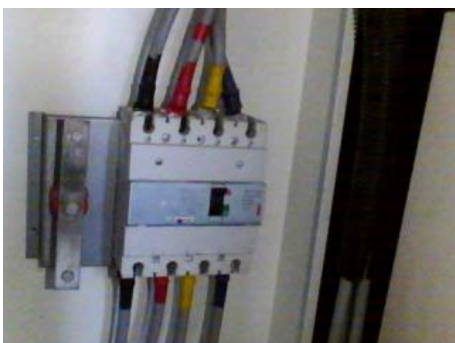
| Sr. No. | Thermal Image | Visual Image | Remarks |
|---|---|---|---|
| 43 | | | <b>Location:</b> Meter room, A-Wing, Main MCCB<br><b>Code:</b> 5<br><b>Remarks:</b> Normal<br>No action |

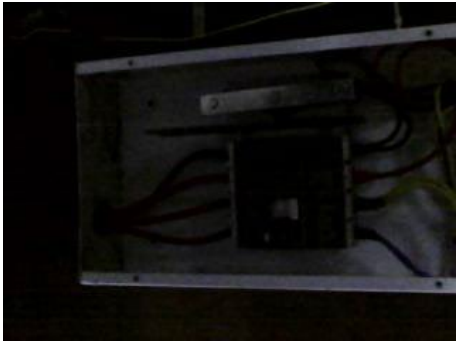
| Sr. No. | Thermal Image | Visual Image | Remarks |
|---|---|---|---|
| 45 | | | <b>Location:</b> Meter room,<br>100 A FP MCCB<br><b>Code:</b> 5<br><b>Remarks:</b> Normal<br>No action |

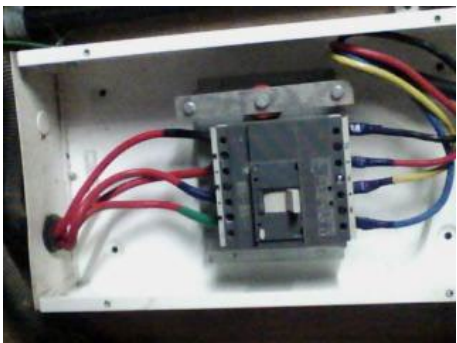
| Sr. No. | Thermal Image | Visual Image | Remarks |
|---|---|---|---|
| 46 | | | <b>Location:</b> Meter room,<br>100 A FP MCCB<br><b>Code:</b> 5<br><b>Remarks:</b> Normal<br>No action |

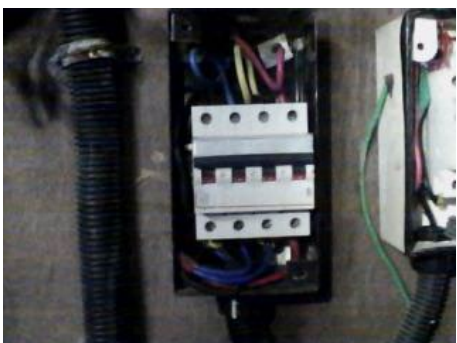
| Sr. No. | Thermal Image | Visual Image | Remarks |
|---|---|---|---|
| 47 | | | <b>Location:</b> Meter room,<br>25 A FP MCB<br><b>Code:</b> 5<br><b>Remarks:</b> Normal<br>No action |

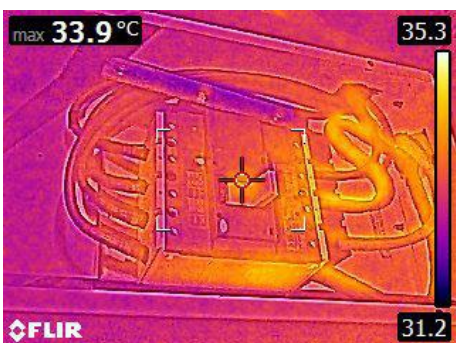
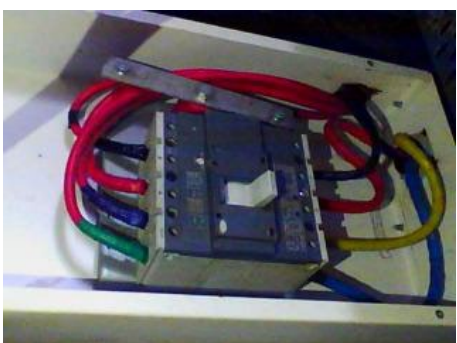
| Sr. No. | Thermal Image | Visual Image | Remarks |
|---|---|---|---|
| 48 | | | <b>Location:</b> Meter room,<br>100 A FP MCCB<br><b>Code:</b> 5<br><b>Remarks:</b> Normal<br>No action |

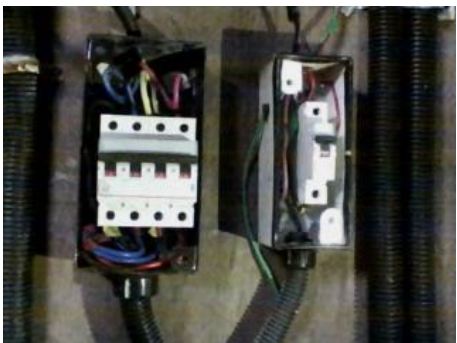
| Sr. No. | Thermal Image | Visual Image | Remarks |
|---|---|---|---|
| 50 | | | <b>Location:</b> Meter room,<br>125 A FP MCCB<br><b>Code:</b> 5<br><b>Remarks:</b> Normal<br>No action |

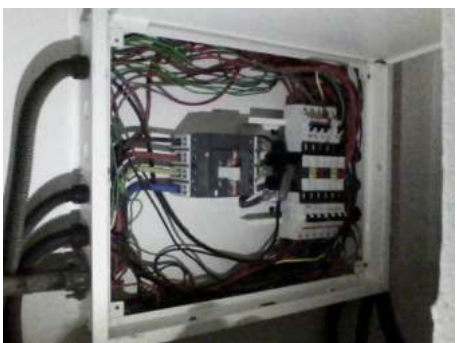
| Sr. No. | Thermal Image | Visual Image | Remarks |
|---|---|---|---|
| 51 | | | <b>Location:</b> Ground Floor,<br>A-Wing DB<br>80 A FP MCB<br><b>Code:</b> 5<br><b>Remarks:</b> Normal<br>No action |

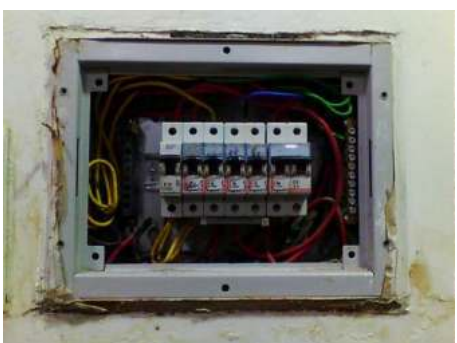
| Sr. No. | Thermal Image | Visual Image | Remarks |
|---|---|---|---|
| 52 | | | <b>Location:</b> Ground Floor,<br>A-002 DB<br><b>Code:</b> 5<br><b>Remarks:</b> Normal<br>No action |

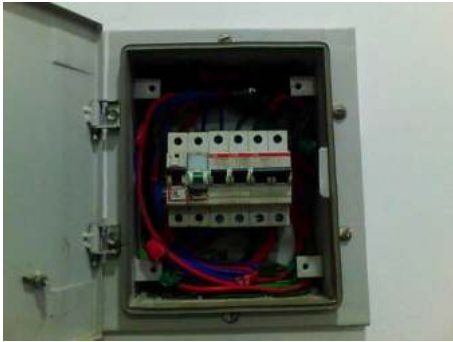
| Sr. No. | Thermal Image | Visual Image | Remarks |
|---|---|---|---|
| 53 | | | <b>Location:</b> Ground Floor, A-005 DB<br><b>Code:</b> 5<br><b>Remarks:</b> Normal<br>No action |

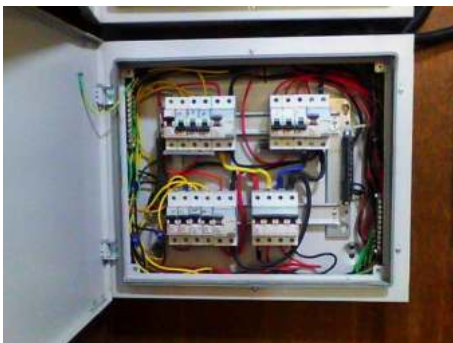
| Sr. No. | Thermal Image | Visual Image | Remarks |
|---|---|---|---|
| 54 | | | <b>Location:</b> Ground Floor, A-004 Light and Power DB<br><b>Code:</b> 5<br><b>Remarks:</b> Normal<br>No action |

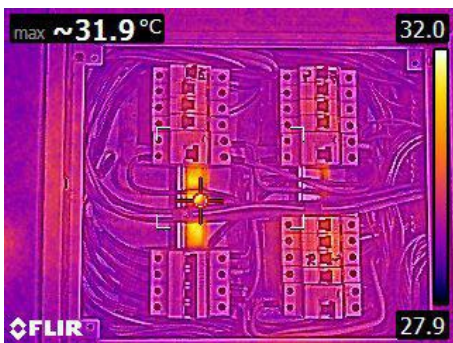
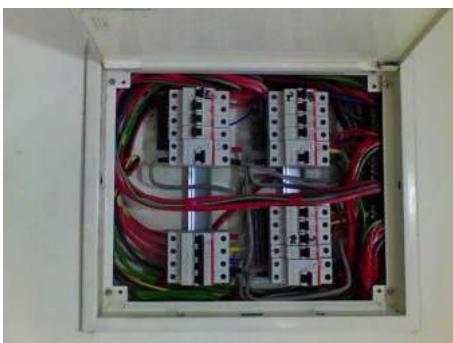
| Sr. No. | Thermal Image | Visual Image | Remarks |
|---|---|---|---|
| 55 | | | <b>Location:</b> Ground Floor, A-003 Banquet Hall<br><b>Code:</b> 5<br><b>Remarks:</b> Normal<br>No action |

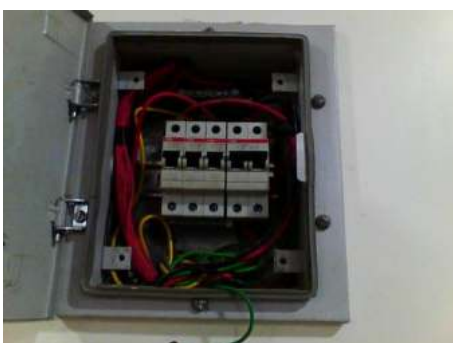
| Sr. No. | Thermal Image | Visual Image | Remarks |
|---|---|---|---|
| 56 | | | <b>Location:</b> Ground Floor, B-01 Guest room<br><b>Code:</b> 5<br><b>Remarks:</b> Normal<br>No action |

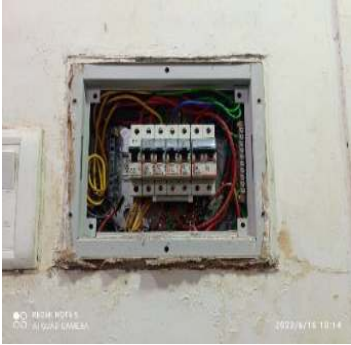
| Sr. No. | Photograph | Observations | Risk Category |
|---|---|---|---|
| 1 | | <p><b>Location: 002</b></p> <p><b>Non- Compliance:</b><br/>ELCB was not provided for the DB<br/>Dust was found accumulated in the DB</p> <p><b>Recommendations:</b><br/>ELCB must be provided for protection against earth leakage current<br/>All apparatus shall be maintained reasonably free from dust, dirt and moisture, and shall be kept clear of obstructions</p> | Medium |

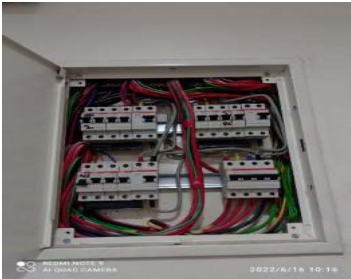
| Sr. No. | Photograph | Observations | Risk Category |
|---|---|---|---|
| 2 | | <p><b>Location: 003</b></p> <p><b>Non- Compliance:</b><br/>Loose wiring was observed inside the DB<br/>There was no double door cover plate provided for DB</p> <p><b>Recommendations:</b><br/>Wiring should be properly routed with cable ties<br/>Double cover plate should be provided for DB to avoid exposure to cables and terminations.</p> | High |

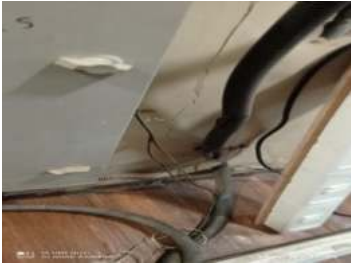
| Sr. No. | Photograph | Observations | Risk Category |
|---|---|---|---|
| 3 | | <p><b>Location: 1<sup>st</sup> Floor Meter Room</b></p> <p><b>Non- Compliance:</b><br/>Cables were hanging near the DB</p> <p><b>Recommendations:</b><br/>Cables should be properly terminated with help of cable saddle or cable tray</p> | Medium |

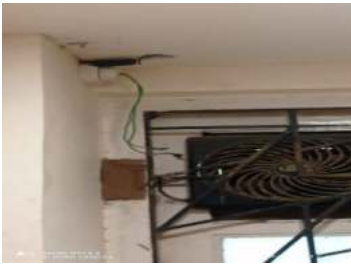
| Sr. No. | Photograph | Observations | Risk Category |
|---|---|---|---|
| 4 | | <p><b>Location: 1<sup>st</sup> Floor Meter Room</b></p> <p><b>Non- Compliance:</b><br/>Wire termination was not done properly</p> <p><b>Recommendations:</b><br/>All fire rated power cables should be routed properly through fire rated plastic conduits<br/>Cable termination should be done using cable connector kit.</p> | Medium |

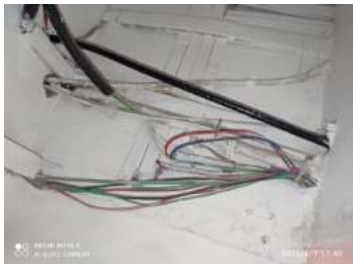
| Sr. No. | Photograph | Observations | Risk Category |
|---|---|---|---|
| 9 | | <p><b>Location: B Side 1<sup>st</sup> Floor DB</b></p> <p><b>Non- Compliance:</b><br/>Wires were not properly routed.</p> <p><b>Recommendations:</b><br/>All wires must be routed properly using casing and capping arrangements</p> | Medium |

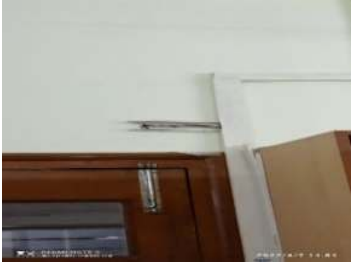
| Sr. No. | Photograph | Observations | Risk Category |
|---|---|---|---|
| 10 | | <p><b>Location: B 201</b></p> <p><b>Non- Compliance:</b><br/>Casing and Caping arrangement were observed to be in open condition</p> <p><b>Recommendations:</b><br/>All wires must be routed properly using casing &amp; capping arrangements.</p> | Low |

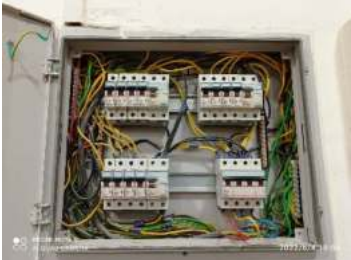
| Sr. No. | Photograph | Observations | Risk Category |
|---|---|---|---|
| 14 | | <p><b>Location: 303 A</b></p> <p><b>Non- Compliance:</b><br/>Loose wiring was observed inside the DB</p> <p><b>Recommendations:</b><br/>Wiring should be properly routed using cable ties</p> | Medium |

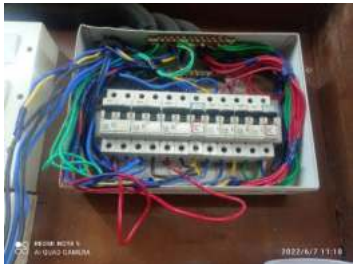
| Sr. No. | Photograph | Observations | Risk Category |
|---|---|---|---|
| 18 | | <p><b>Location: 302 B</b></p> <p><b>Non- Compliance:</b><br/>Improper wire routing was observed inside the DB</p> <p><b>Recommendations:</b><br/>Wiring should be properly routed using cable ties</p> | Medium |

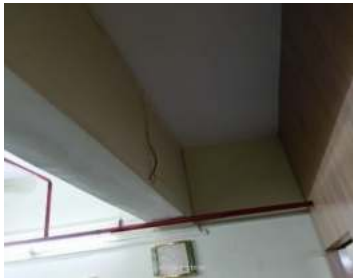
| Sr. No. | Photograph | Observations | Risk Category |
|---|---|---|---|
| 19 | | <p><b>Location: 403 A</b></p> <p><b>Non- Compliance:</b><br/>Wire was observed hanging from the ceiling</p> <p><b>Recommendations:</b><br/>Wire must be routed properly with casing and capping arrangement.</p> | Low |

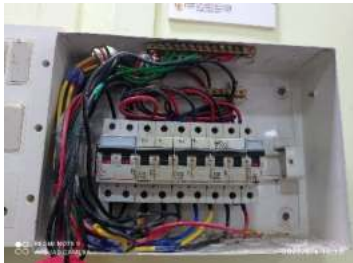
| Sr. No. | Photograph | Observations | Risk Category |
|---|---|---|---|
| 20 | | <p><b>Location: B 404</b></p> <p><b>Non- Compliance:</b><br/>Improper wire routing inside was observed inside the DB</p> <p><b>Recommendations:</b><br/>Wiring should be properly routed using cable ties</p> | Medium |

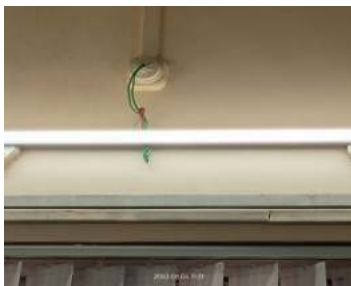
| Sr. No. | Photograph | Observations | Risk Category |
|---|---|---|---|
| 22 | | <p><b>Location: A 501</b></p> <p><b>Non- Compliance:</b><br/>Wires were not connected properly and they were directly joined without using any connector or junction terminal</p> <p><b>Recommendations:</b><br/>The wires must be joined by using connectors</p> | Low |

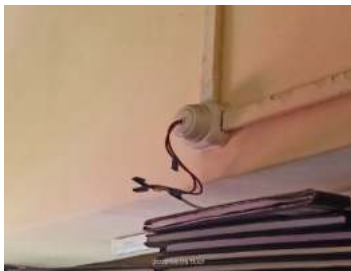
| Sr. No. | Photograph | Observations | Risk Category |
|---|---|---|---|
| 24 | | <p><b>Location: A 504</b></p> <p><b>Non- Compliance:</b><br/>Cable was not terminated using PVC connector</p> <p><b>Recommendations:</b><br/>Termination should be done properly with help of PVC connector</p> | Low |

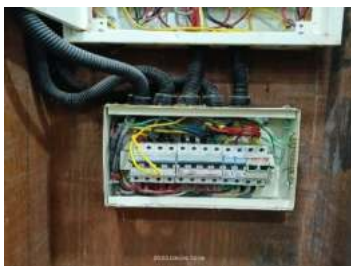
| Sr. No. | Photograph | Observations | Risk Category |
|---|---|---|---|
| 25 | | <p><b>Location: B 501</b></p> <p><b>Non- Compliance:</b><br/>No ELCB was provided for the DB.<br/>Loose wiring was observed inside the DB.</p> <p><b>Recommendations:</b><br/>ELCB should be provided for protection against earth leakage current<br/>Wiring should be properly routed using cable ties</p> | High |

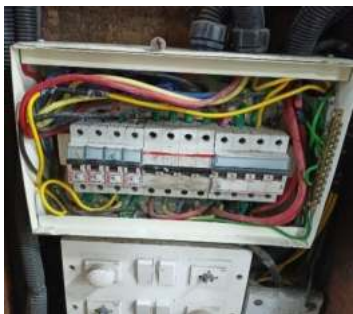
| Sr. No. | Photograph | Observations | Risk Category |
|---|---|---|---|
| 27 | | <p><b>Location: B 502</b></p> <p><b>Non- Compliance:</b><br/>No ELCB was provided for the DB<br/>Loose wiring was observed inside the DB</p> <p><b>Recommendations:</b><br/>ELCB should be provided for protection against earth leakage current<br/>Wiring should be properly routed using cable ties</p> | High |

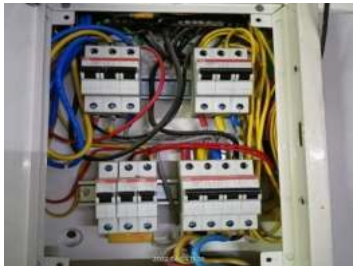
| Sr. No. | Photograph | Observations | Risk Category |
|---|---|---|---|
| 28 | | <p><b>Location: 5<sup>TH</sup> Floor A wing DB</b></p> <p><b>Non- Compliance:</b><br/>No ELCB was provided for the DB<br/>Loose wiring was observed inside the DB</p> <p><b>Recommendations:</b><br/>ELCB should be provided for protection against earth leakage current<br/>Wiring should be properly routed using cable ties</p> | High |

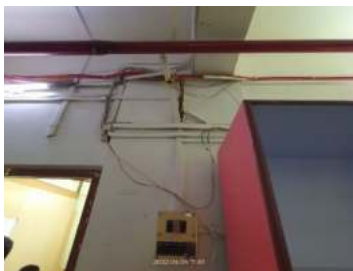
| Sr. No. | Photograph | Observations | Risk Category |
|---|---|---|---|
| 29 | | <p><b>Location: 5<sup>th</sup> Floor Passage</b></p> <p><b>Non- Compliance:</b><br/>Wires were not routed properly using casing and capping arrangement</p> <p><b>Recommendations:</b><br/>All wires must be routed properly within casing and capping arrangement</p> | Low |

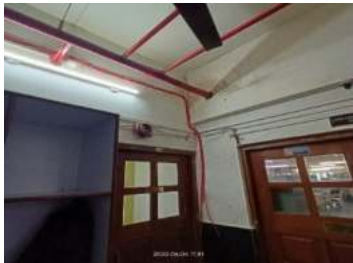
| Sr. No. | Photograph | Observations | Risk Category |
|---|---|---|---|
| 30 | | <p><b>Location: 5<sup>th</sup> Floor Passage</b></p> <p><b>Non- Compliance:</b><br/>Wire was not routed properly in casing and capping arrangement</p> <p><b>Recommendations:</b><br/>All wires must be routed properly using support casing and capping arrangement</p> | Low |

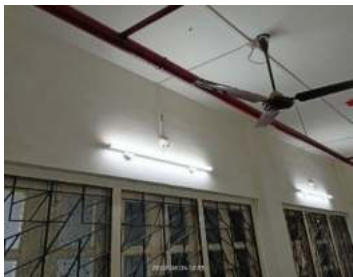
| Sr. No. | Photograph | Observations | Risk Category |
|---|---|---|---|
| 32 | | <p><b>Location: 5<sup>th</sup> Floor Passage</b></p> <p><b>Non- Compliance:</b><br/>The fan blade was in direct contact with the fire hydrant line.</p> <p><b>Recommendations:</b><br/>Length of ceiling rod should be increased for preventing fan and fire hydrant line getting damaged</p> | High |

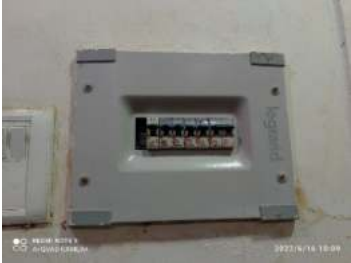
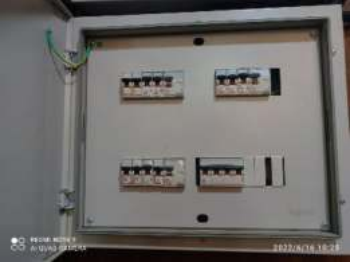
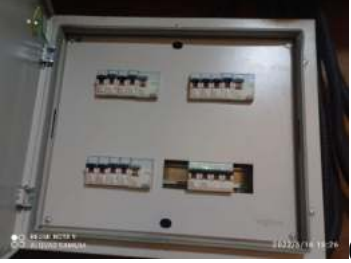
| Classroom #002 | 004 DB- 1 | DB- 2 |

**Non-Compliance:**

Dummy Plate was not observed in the DB

**Recommendations:**

Dummy Plate must be provide for the DB to avoid entry of lizard or dust inside panel
